Inspection Report

RE-Built

1 Sample Road,
Hamilton

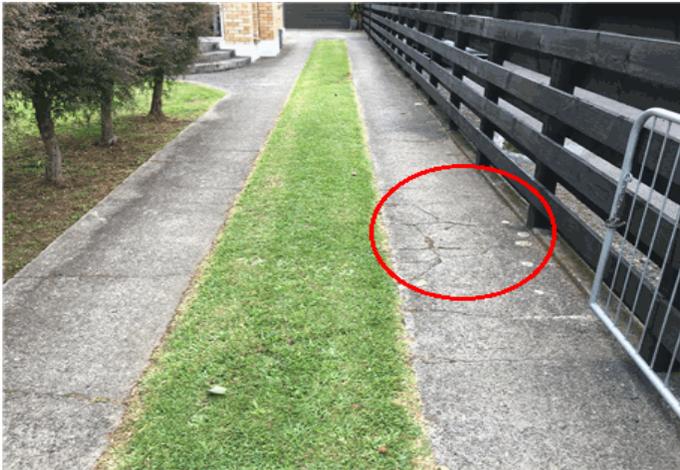
2) Driveway Conditions

The concrete driveway is cracked in places.

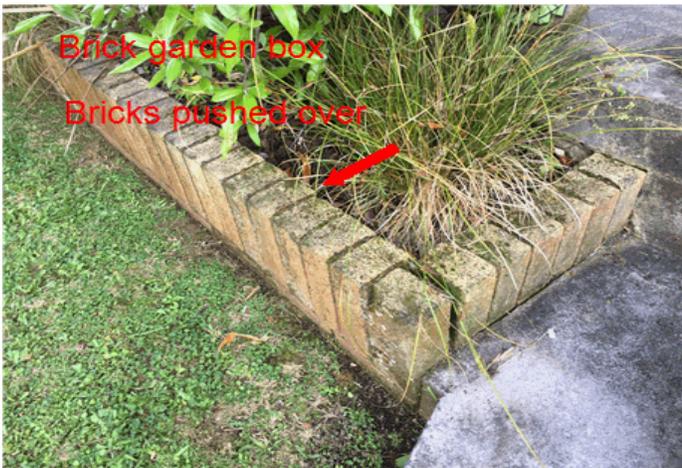
4) Garden Box Conditions

The face of the brick garden box has been pushed over somewhat by plant roots..

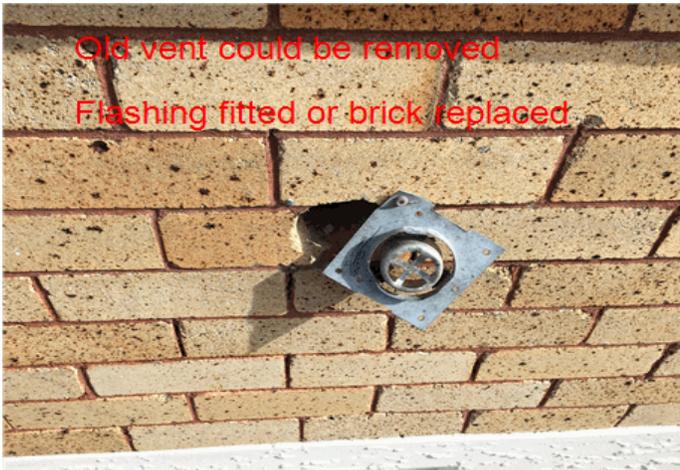
5) Exterior Wall Conditions

A disused vent could be removed, a flashing could be fitted in it's place or the brick could be replaced.

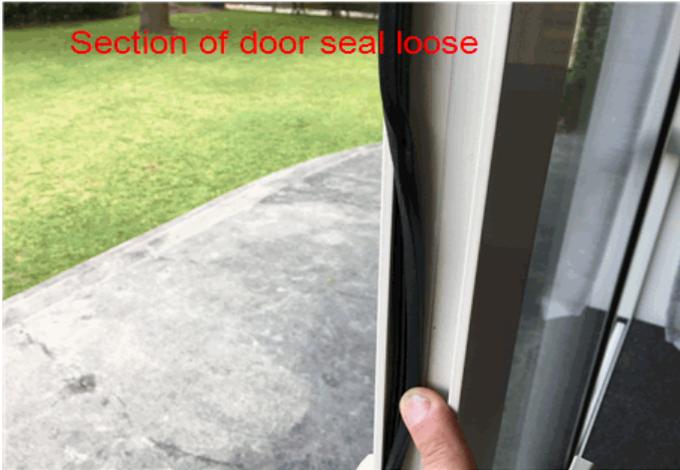
7) Exterior Door Conditions

A section of Ranch Slider door seal is detached.

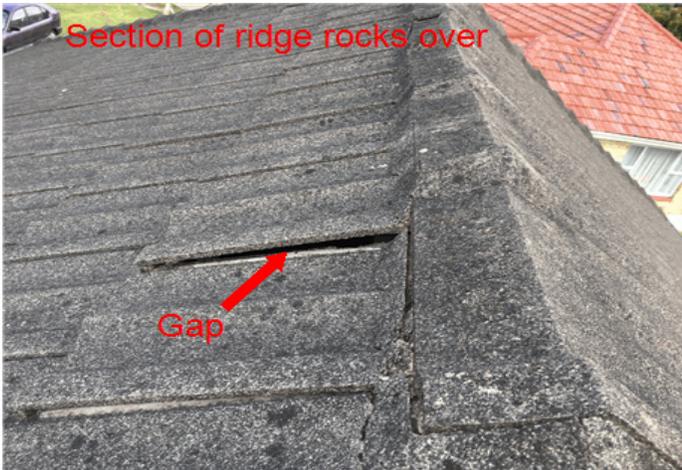
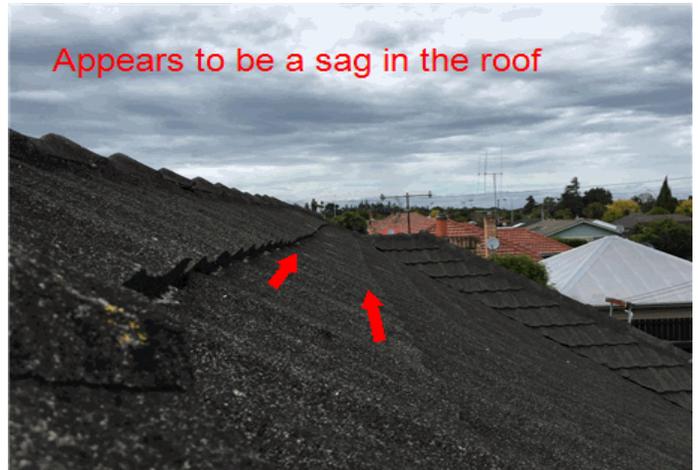
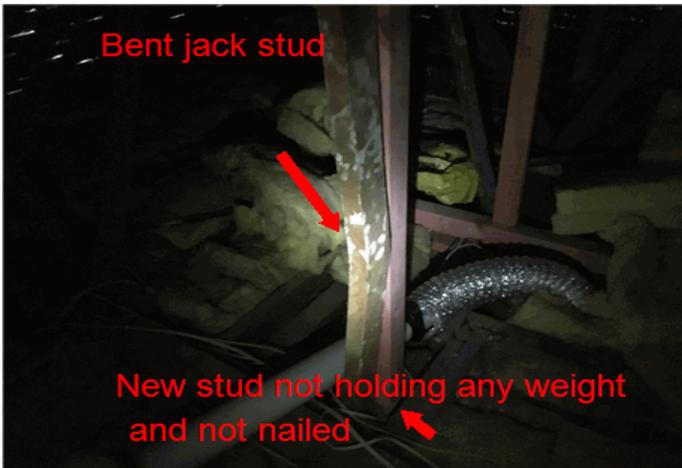
10) Roof Covering Condition

The tiles along the roof ridge can be rocked from side to side and there is a gap between two tiles. There appears to be a sag in the roof structure, some of the jack studs are bent, an additional stud is not holding any weight and has not been nailed at the bottom.

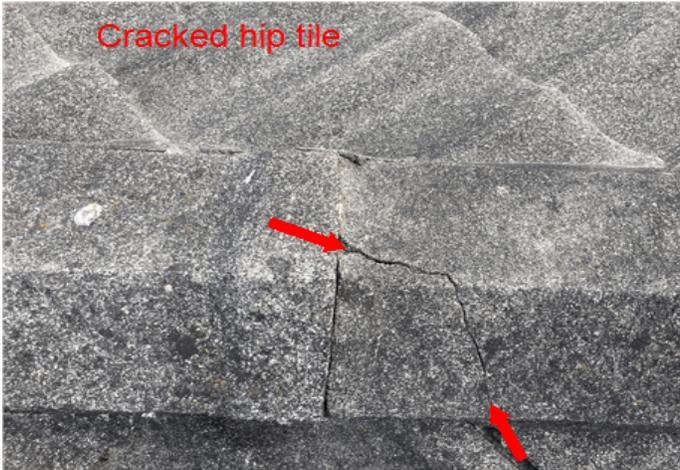
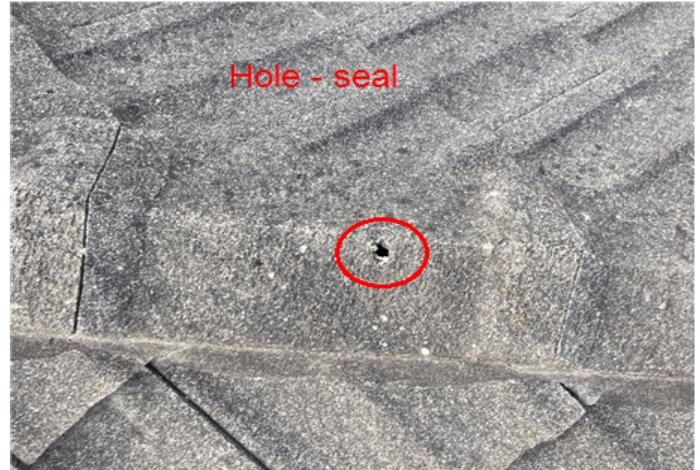
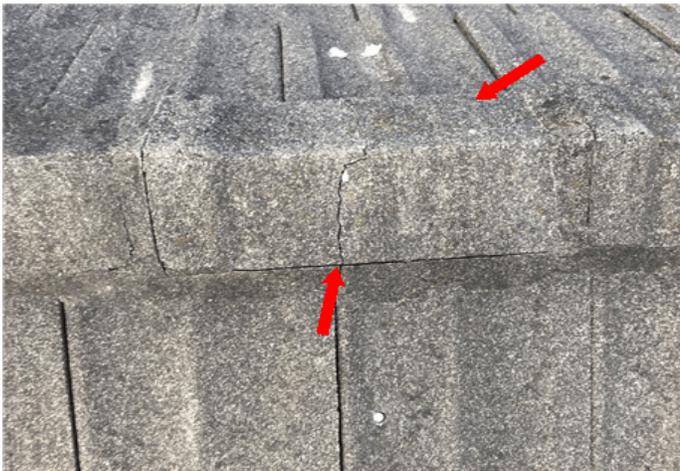
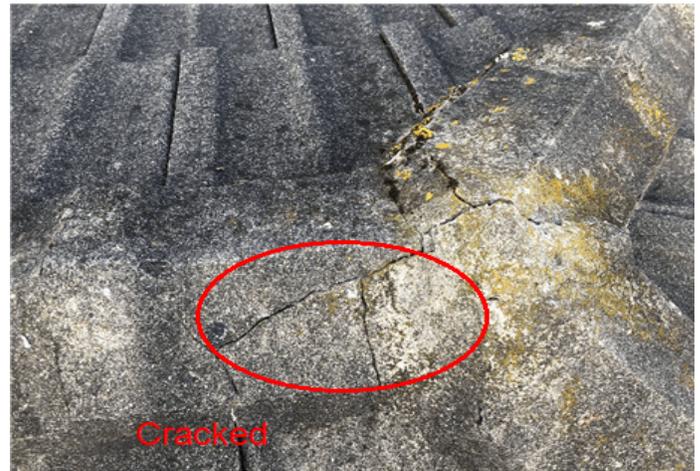
11) Flashing Conditions

A number of hip and ridge tiles are cracked and one has a hole through it.

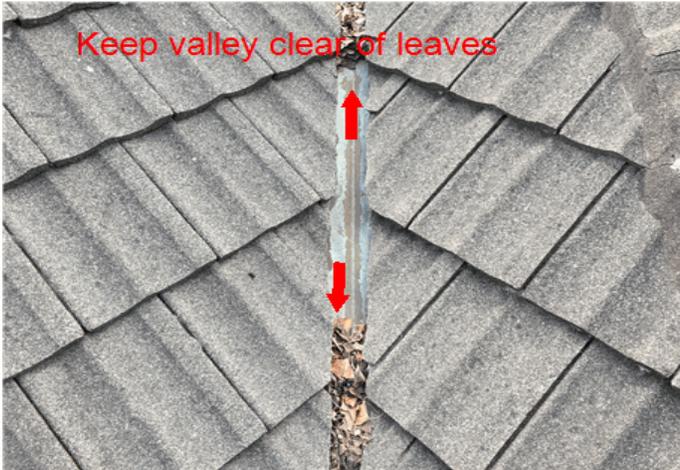
12) Gutter Down-Pipe Conditions

The roof valley should be kept clear of leaves.

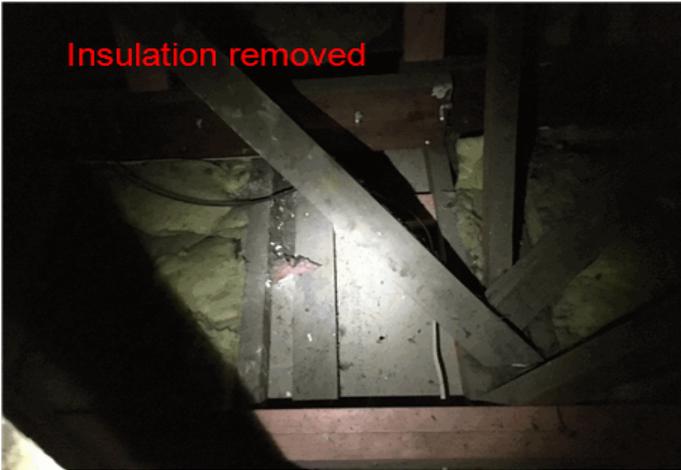
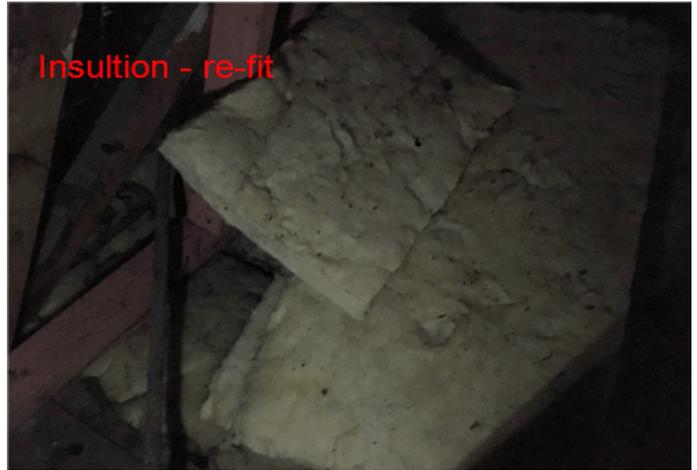
15) Ceiling Insulation Conditions **R** A small area of ceiling insulation has been removed but could be re-fitted. The rating of the insulation is approximately (R1.7) By 1/7/19 the ceiling insulation will need to meet or exceed the rating of R 2.9 if being rented out.

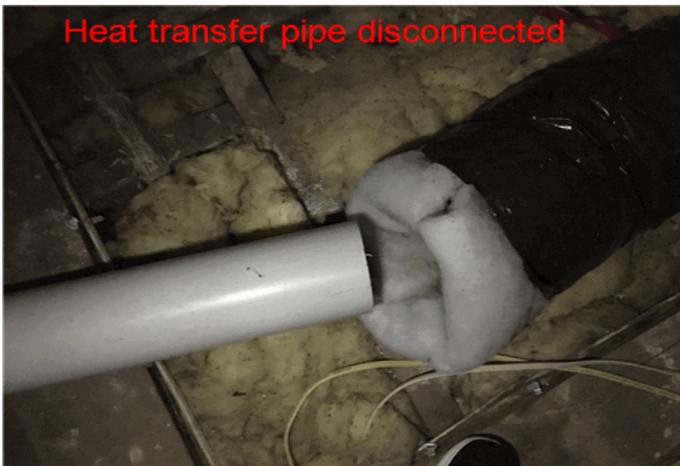
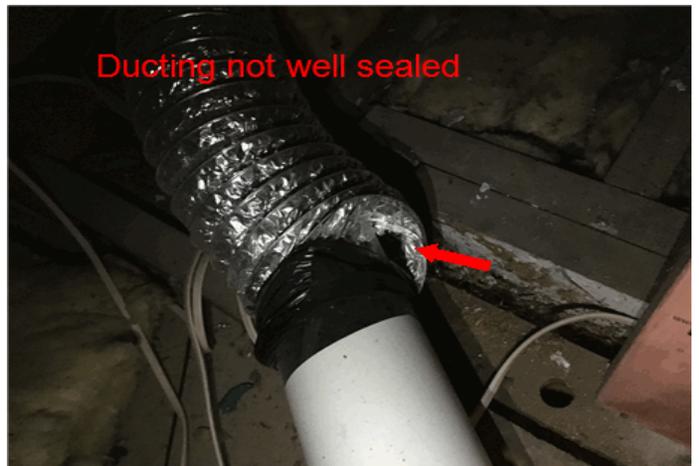
18) Heat Transfer System

A heat transfer pipe has become detached and another joint is not well sealed.

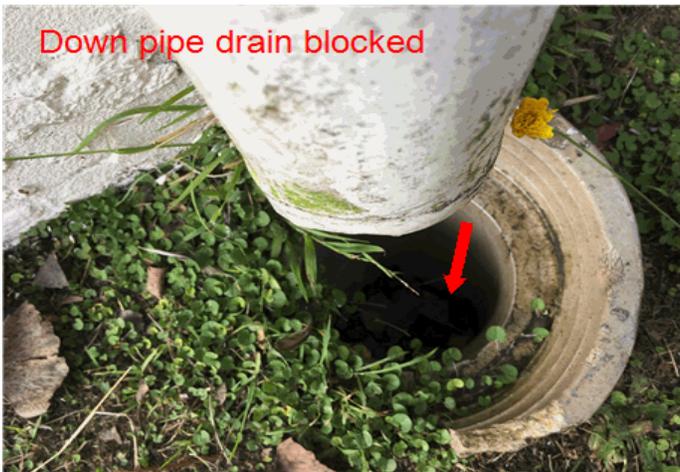
20) Drain Line Conditions

A down pipe drain was blocked with leaves and soil. The pipes may lead to soak holes which often block up over time. It was not raining at the time of my visit.

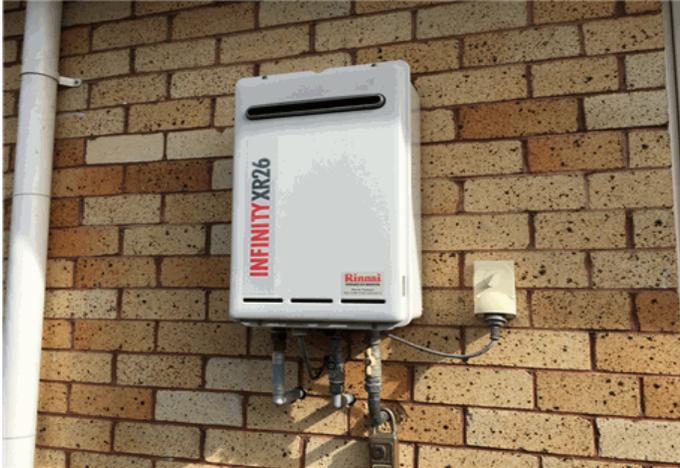
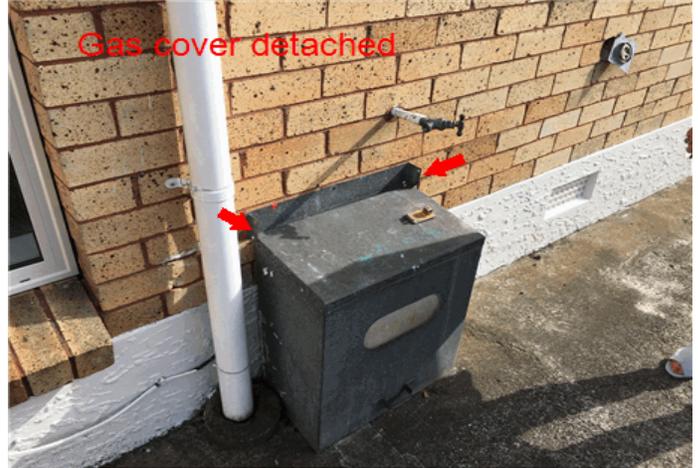
21) Water Heater Conditions

The gas meter cover has become detached.

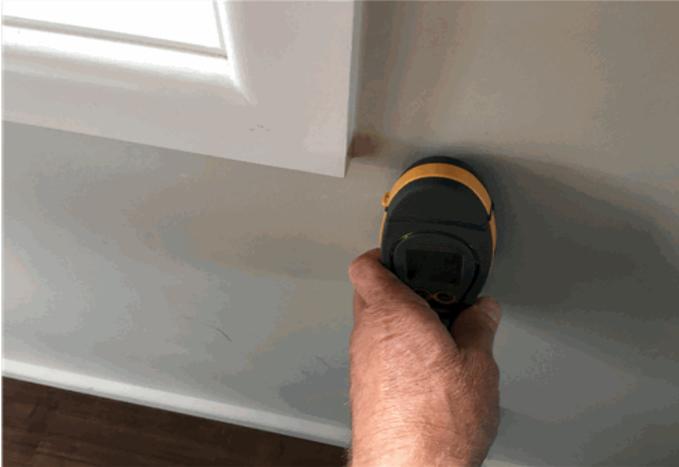
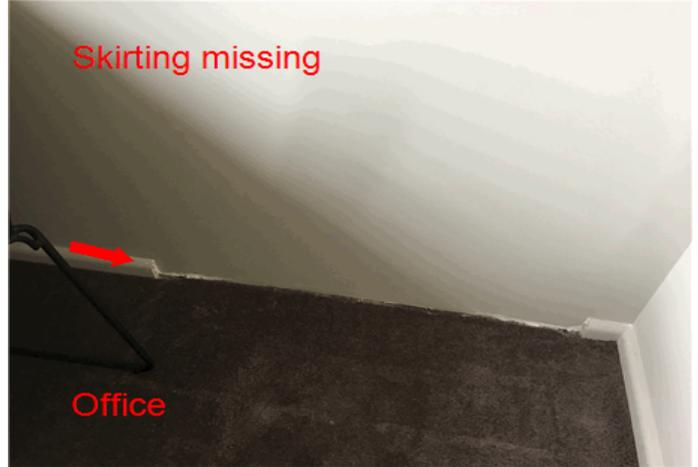
23) Wall Conditions

A section of skirting in the office is missing. No adverse moisture levels were detected in the wall spots tested.

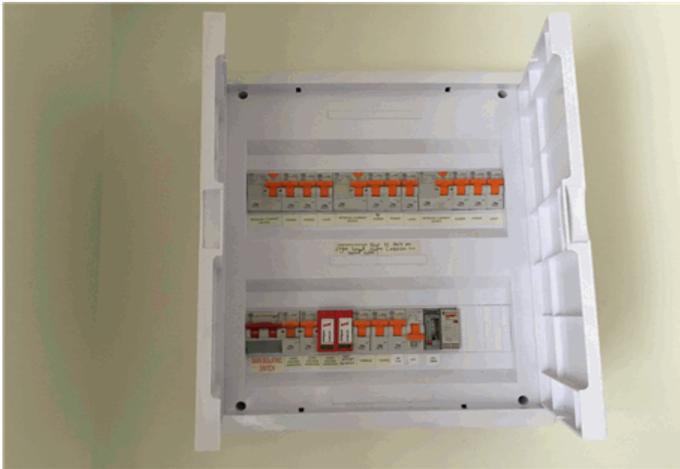
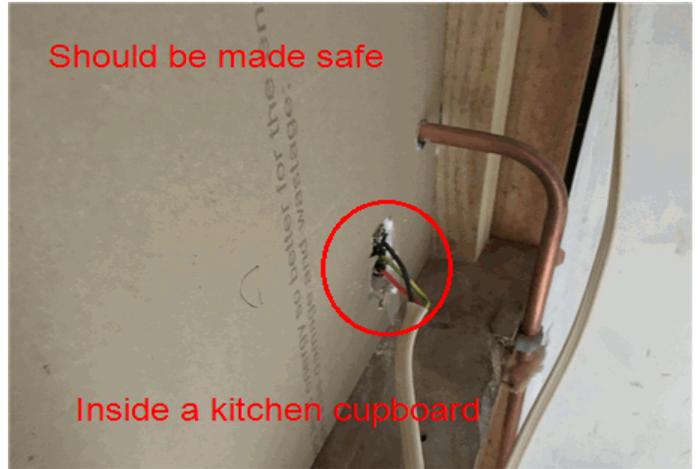
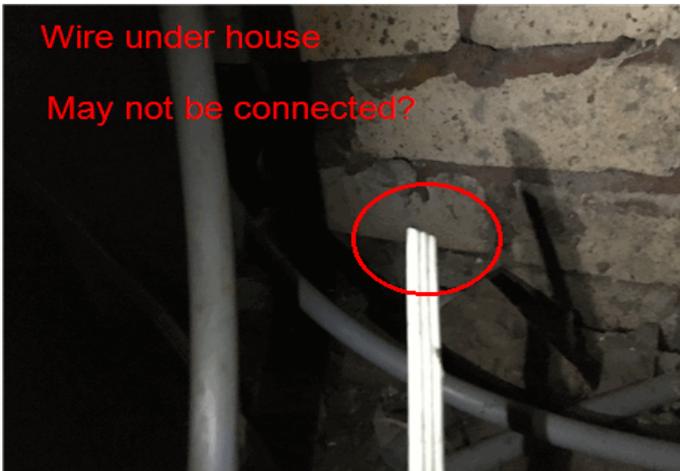
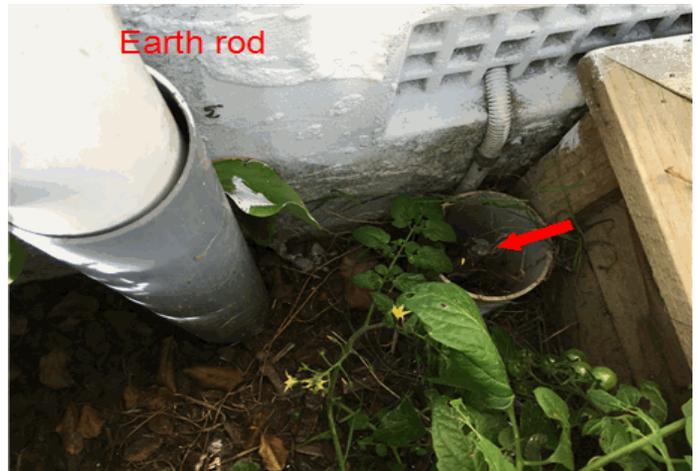
28) Electrical Conditions

Wiring behind a switch inside a kitchen cupboard should be made safe. A cut off wire under the house may or may not be connected to electricity? Extensive wiring replacement appears to have been done. An electrician would be needed if checks are desired to see that no unsafe types of old wiring are still being used, to check switches, and earth rod, etc.

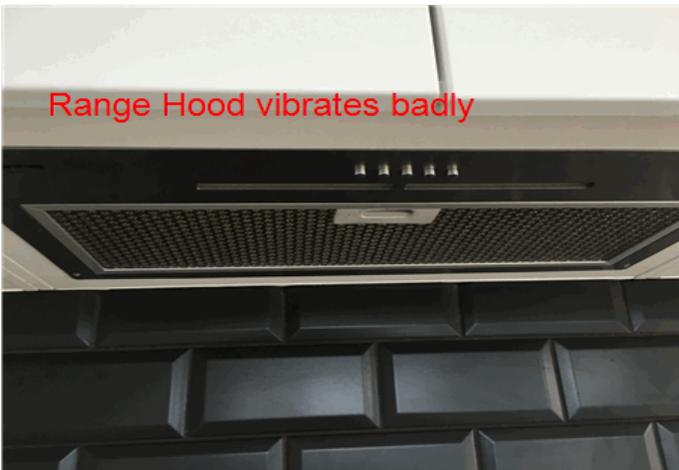
35) Range Hood Conditions

The Range Hood vibrates badly.

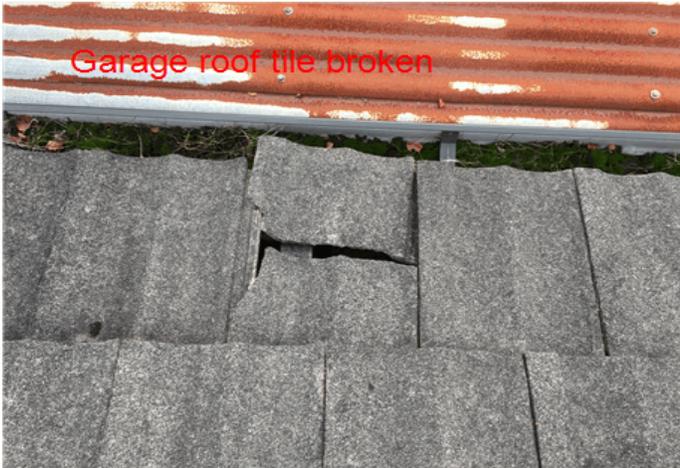
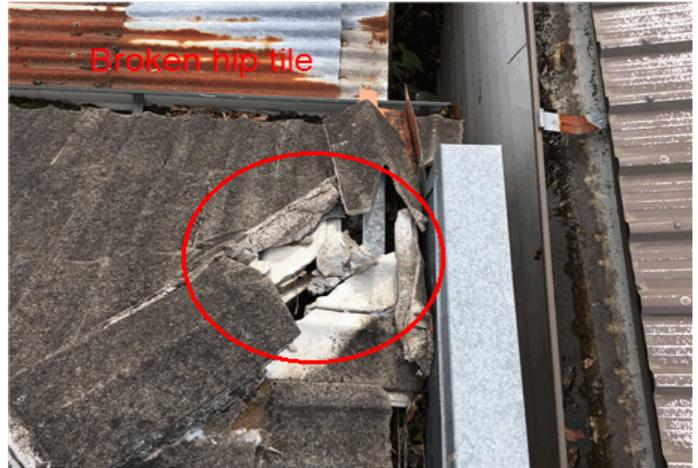
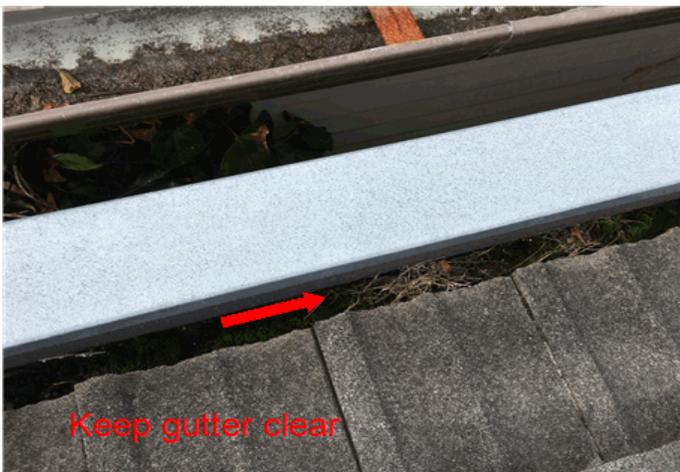
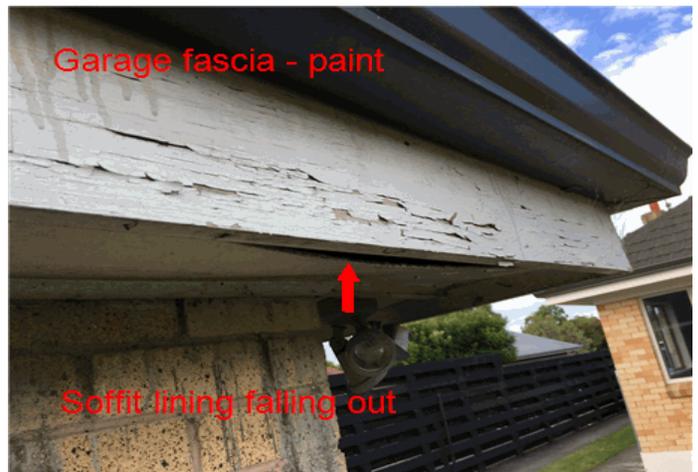
42) Roof Conditions

A garage roof tile is broken as is a hip tile. The internal gutter should be kept clear of debris. The fascia needs to be painted and the soffit lining is falling out in places.

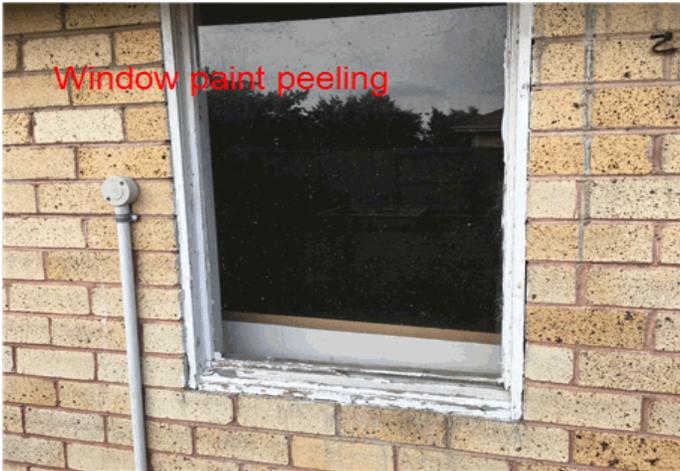
45) Window Conditions

The garage window paint is peeling.

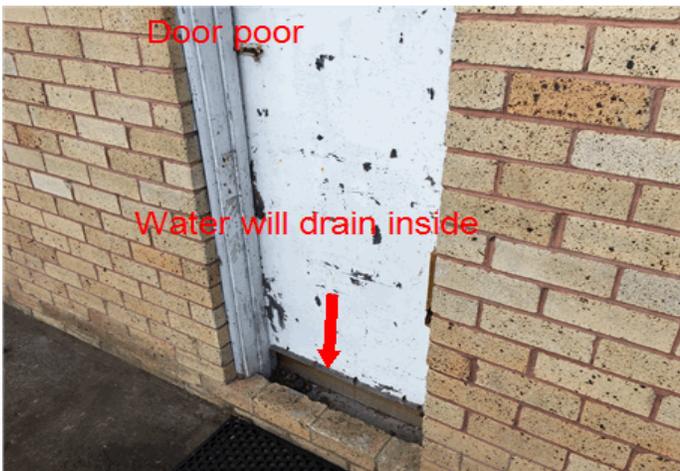
46) Door Conditions

The garage side door is in poor condition and any water that comes into contact with it will drain into the garage.

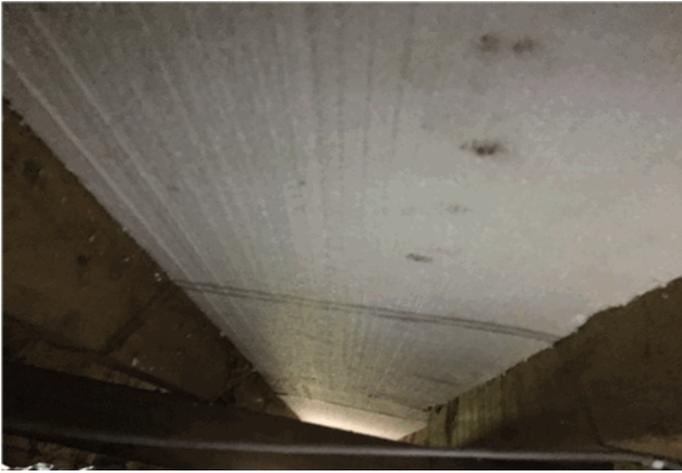
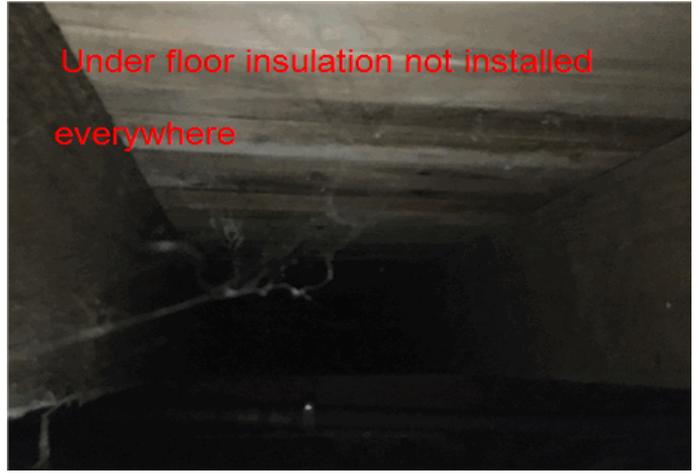
Insulation Type	Polystyrene
51) Insulation Conditions	R Underfloor insulation has not been installed everywhere. The rating of the insulation that is there is approximately (R1.4) By 1/7/19 the underfloor insulation will need to meet or exceed the rating of R 1.3 if being rented out.

Under floor insulation not installed everywhere
